The International Journal of
Prosthodontics

**Mandibular Bone Response
to Plasma-Sprayed
Coatings of Hydroxyapatite**

VOLUME 3
JANUARY/FEBRUARY 1990

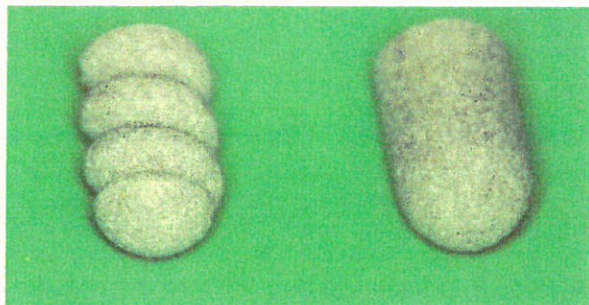
Fig 1 The two experimental plasma-sprayed-hydroxyapatite (PS-HA) designs used in this study. The implant on the left has a grooved surface, while the implant on the right has a smooth cylindrical design with a rounded apex. The occlusal surfaces (not visible) are not coated with HA ceramic.

Two different designs of implants were used (Dyna® Dental Engineering, Bergen op Zoom, The Netherlands). One type had a straight cylindrical design. The second was also cylindrical, but had a grooved surface. The grooves increase the potential bone/HA contacting area. A total of 16 implants with plasma-sprayed coatings of HA was placed. Six implants were cylindrical, while ten implants had a grooved surface (Fig 1).

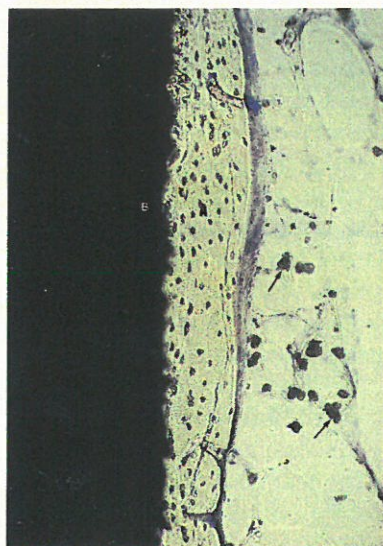
Fig 5 Undecalcified section of methacrylate-embedded mandibular bone (A) adjacent to a cylindrical implant (B) that has been in situ for 9 months. A very tight connection between the lamellar bone and the HA coating is found. Clusters of HA particles are present in the bone marrow (arrows). (Sawed section, Van Gieson stain, original magnification $\times 200$.)

The tissues adjacent to both types of implants showed identical characteristics. In the experimental period, bone was deposited in the extraction socket. Large surface areas of the HA coating were in close contact with the bone. The bone was of the lamellar type and it was mostly laid down as secondary osteons, although deposits directly against HA surfaces were also observed (Figs 5 and 6). In those areas where no connection between HA and bone was established, fatty bone marrow was found. No signs of inflammation were observed. At the apical aspect of the implant there was no bone or only a very thin layer of lamellar bone deposited. Most often the apex protruded freely into the fatty bone marrow (Fig 7). There was no bone deposition occlusal to the implants, and the implants were covered with a fibrous capsule (Fig 8). The outermost layer of the HA coating

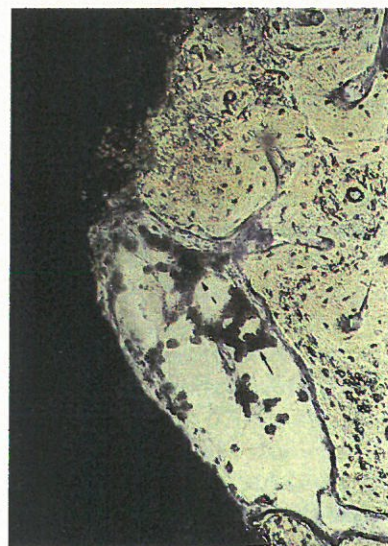
Fig 7 Technique as in Fig 5. In areas where no bone is in direct contact with the implant, fatty bone marrow is found. Clusters of the HA particles (arrows) are found within the marrow. (Original magnification $\times 200$.)

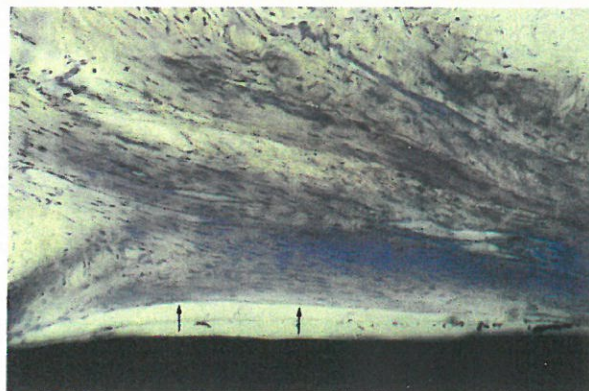
Fig 8 Technique as in Fig 5. The occlusal surface of the implants, which was not coated with HA, is covered with a fibrous connective tissue capsule (arrows). (Original magnification $\times 200$.)
